Mitigation Assessment Team Report

Midwest Floods of 2008 in Iowa and Wisconsin

Building Performance Observations, Recommendations,
and Technical Guidance

FEMA P-765 / October 2009

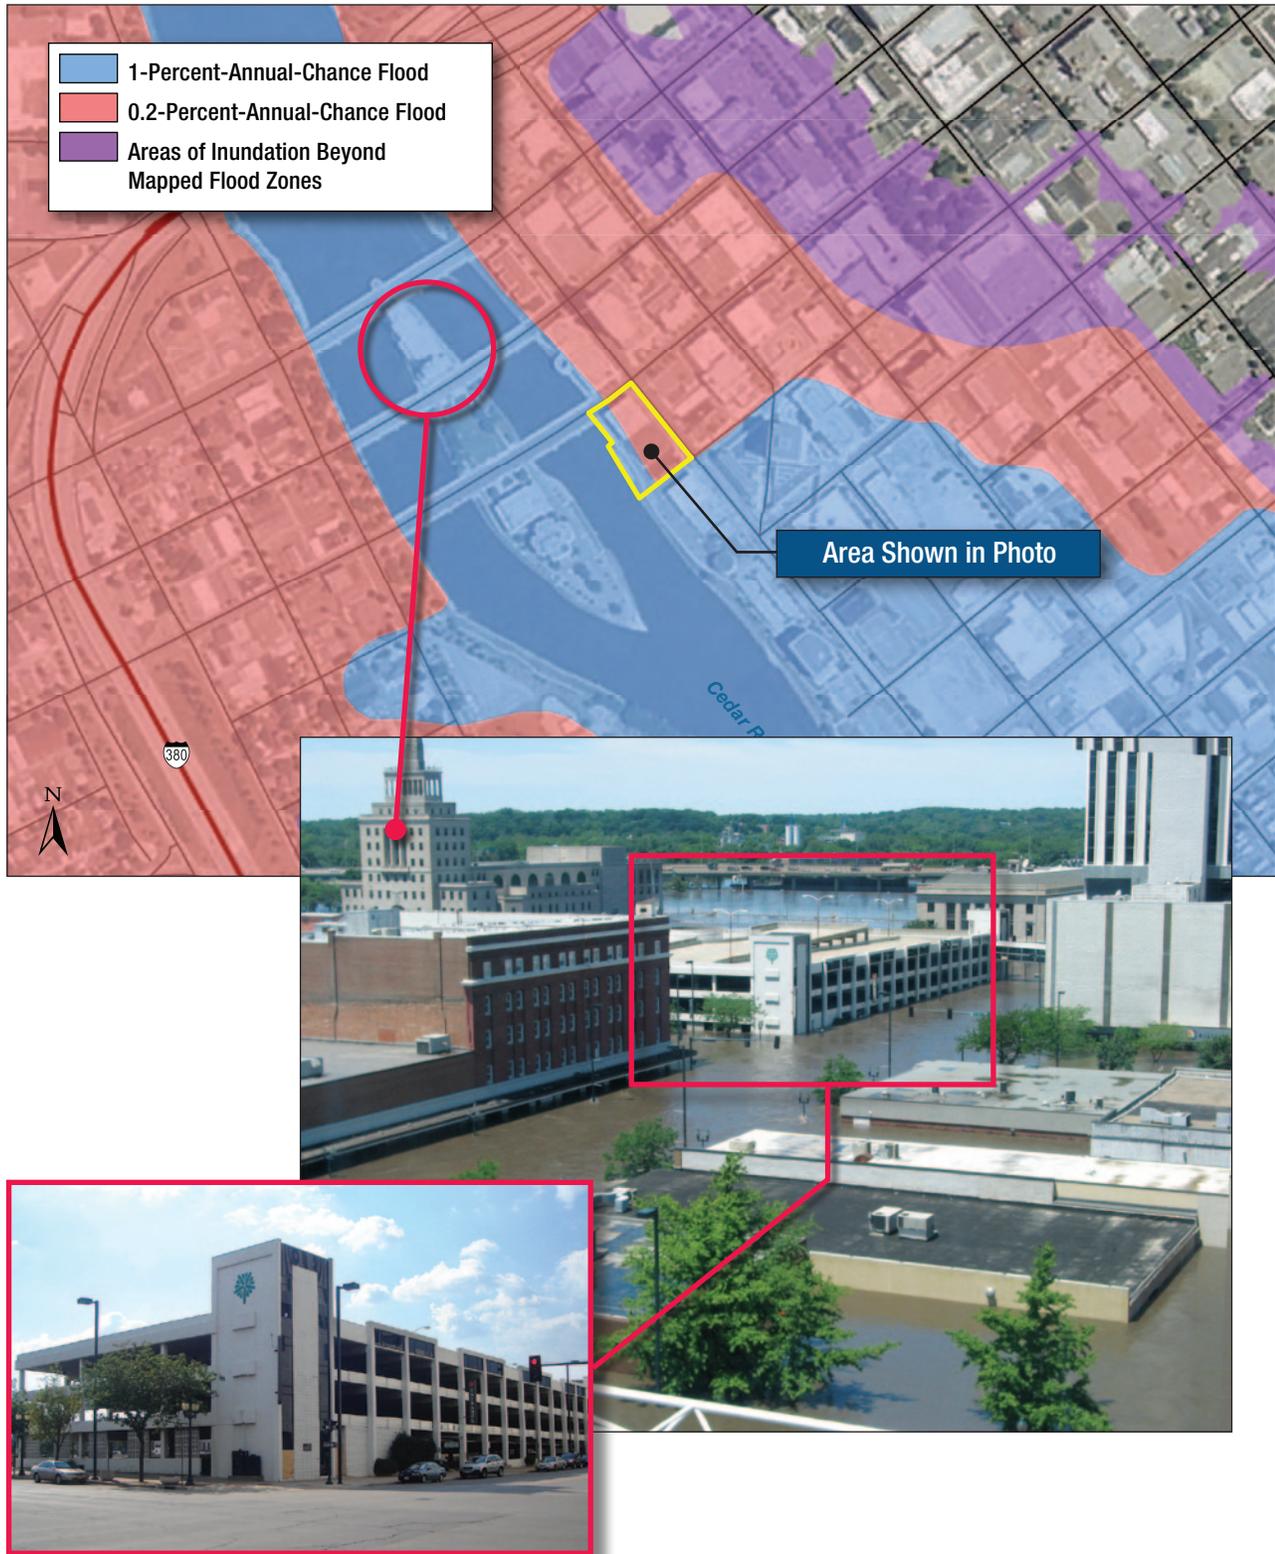
Figure 3-1. Floodwater in the downtown Cedar Rapids commercial district exceeded 6 feet in several buildings, as shown by the parking facility and surrounding properties (Cedar Rapids, Iowa).

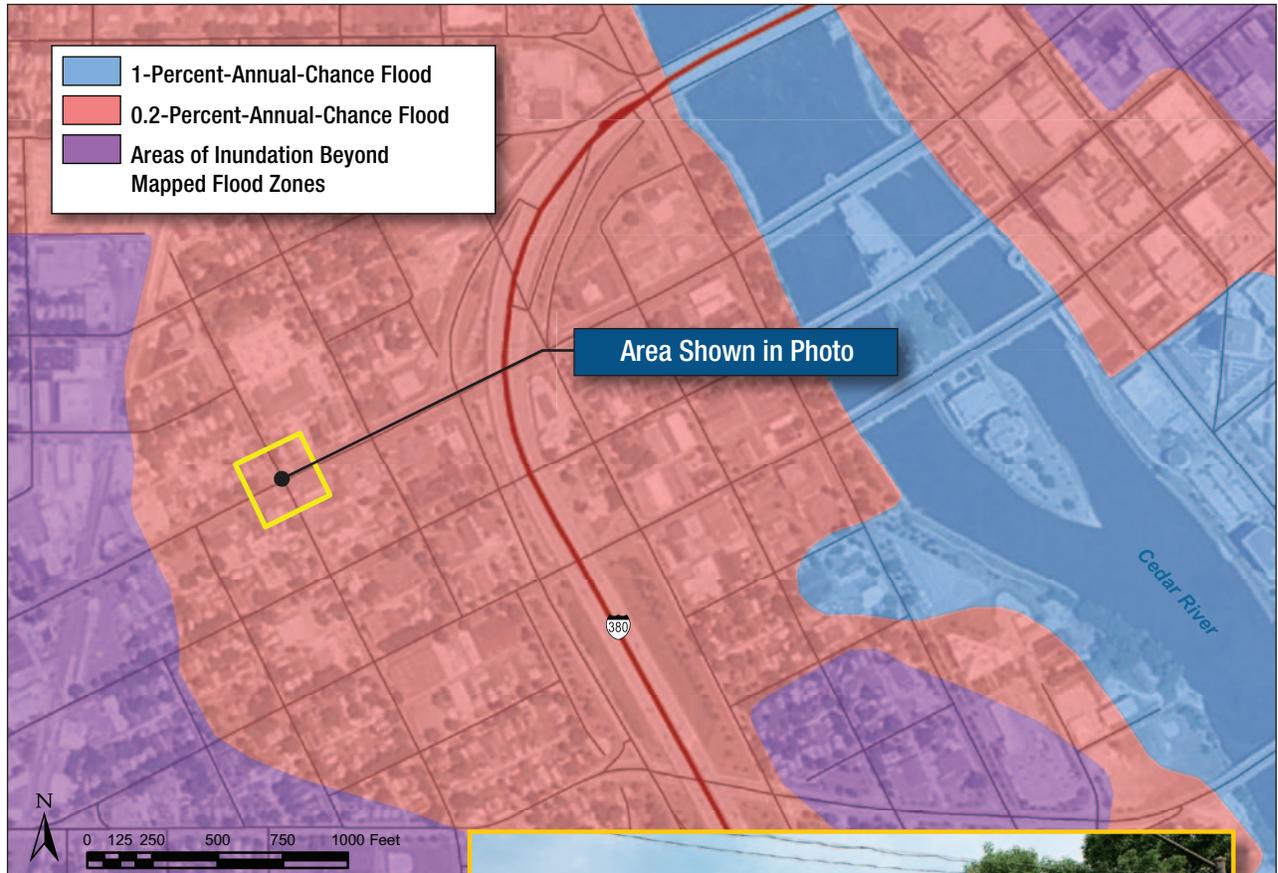
Figure 3-11.
Floodwaters in a residential area of Cedar Rapids during the flood (Cedar Rapids, Iowa).

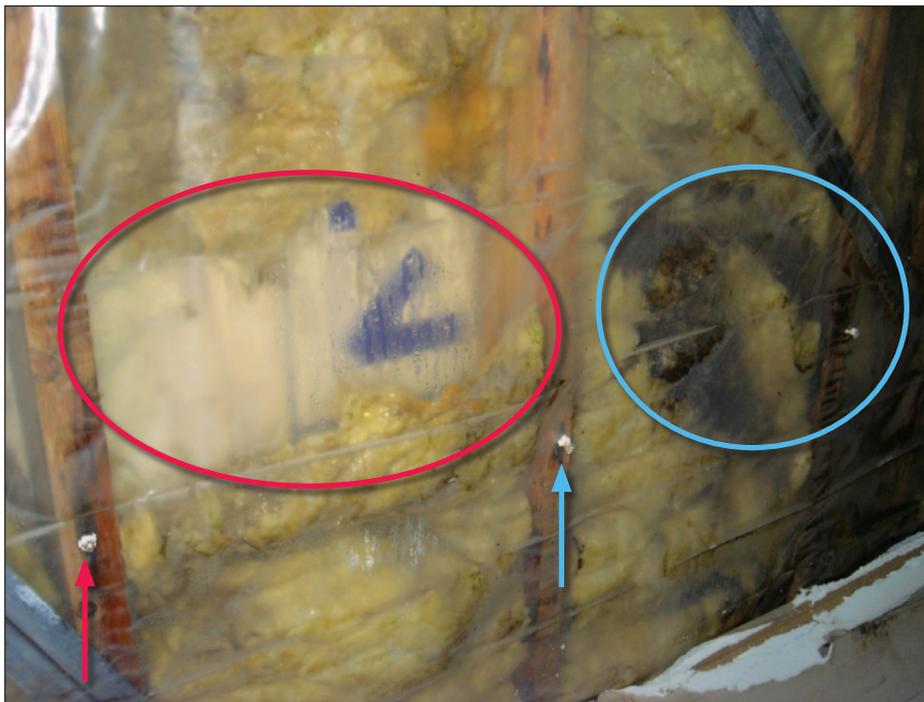
Figure 3-18. Condensation can be seen beading up on the inside face of the vapor barrier (red circle). The increased humidity has initiated the growth of black mold (blue circle), started the rusting of the nails (blue arrow), and the wood is still wet as can be seen by the dark patches on the studs (red arrow) (Cedar Rapids, Iowa).

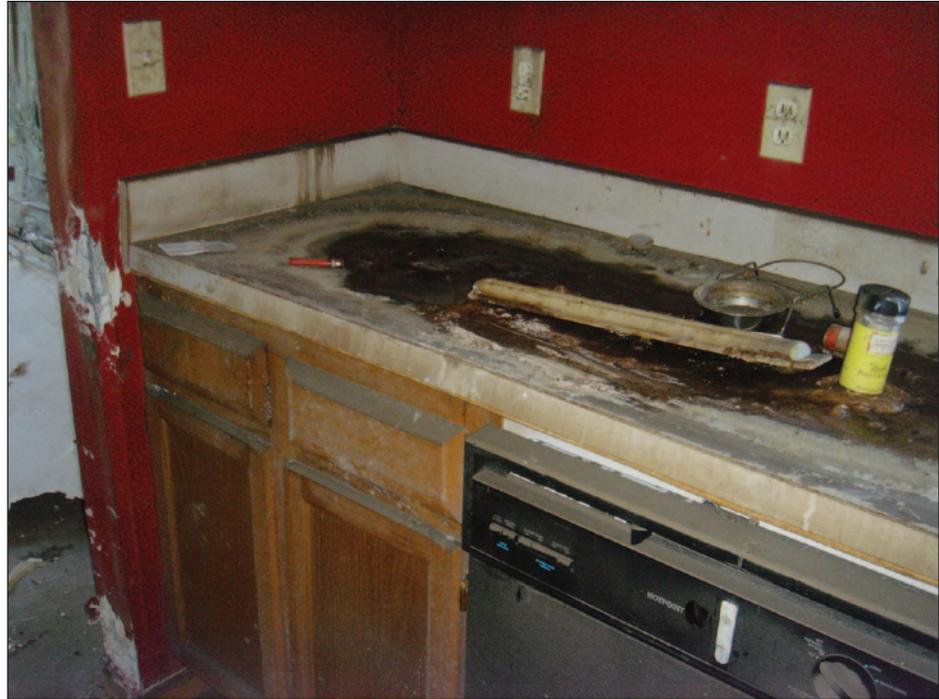
The kitchen countertops, cabinets, appliances, etc., had been submerged and destroyed (Cedar Rapids, Iowa).

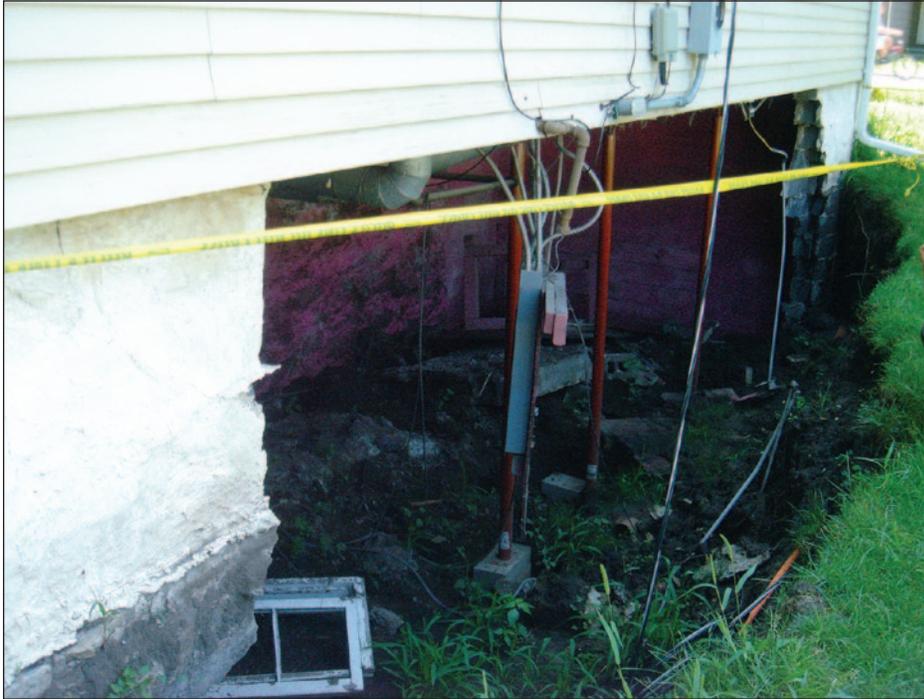
The most common form of structural damage to residential buildings observed by the MAT was the failure of foundation walls, especially those constructed of unreinforced masonry, as a result of lateral pressures from saturated soils and hydrostatic pressure, as illustrated in Figures 3-21 to 3-27.

Figure 3-21.
Failure of unreinforced masonry foundation walls due to hydrostatic pressure observed in various locations in Iowa.

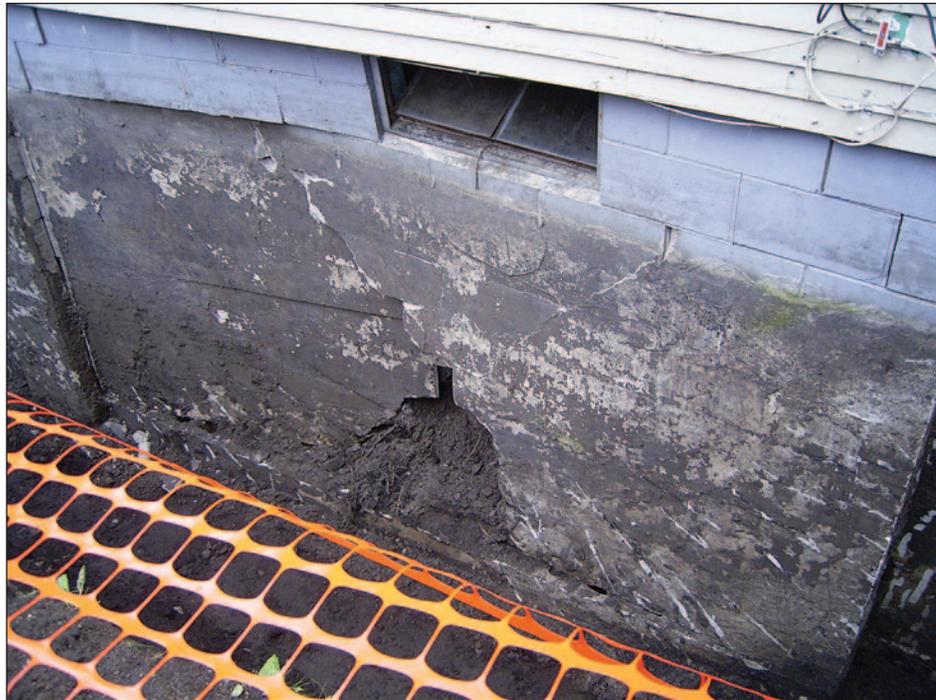
Figure 3-24.
This basement wall failed and almost collapsed due to lateral pressures from saturated soils (Shell Rock, Iowa).

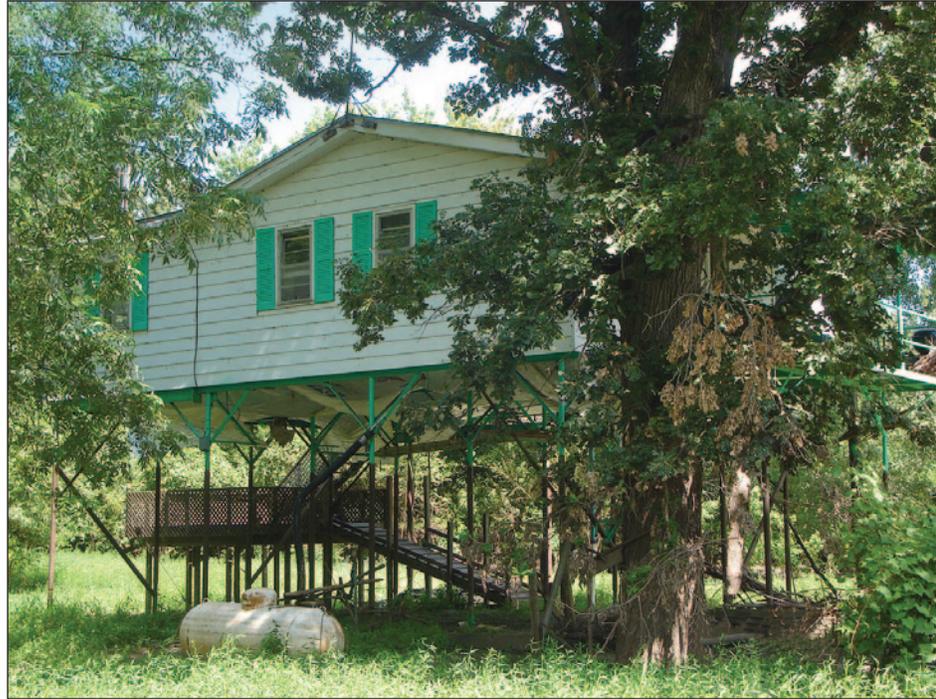
Figure 3-37.
Residential building constructed on open foundation that suffered considerably less damage than those on closed foundations in the same area. Slender columns such as those shown here offer little resistance to lateral loads that can occur from flooding and debris. Accounting for gravity and lateral loads, not just elevation, should be considered during design (Oakville, Iowa).

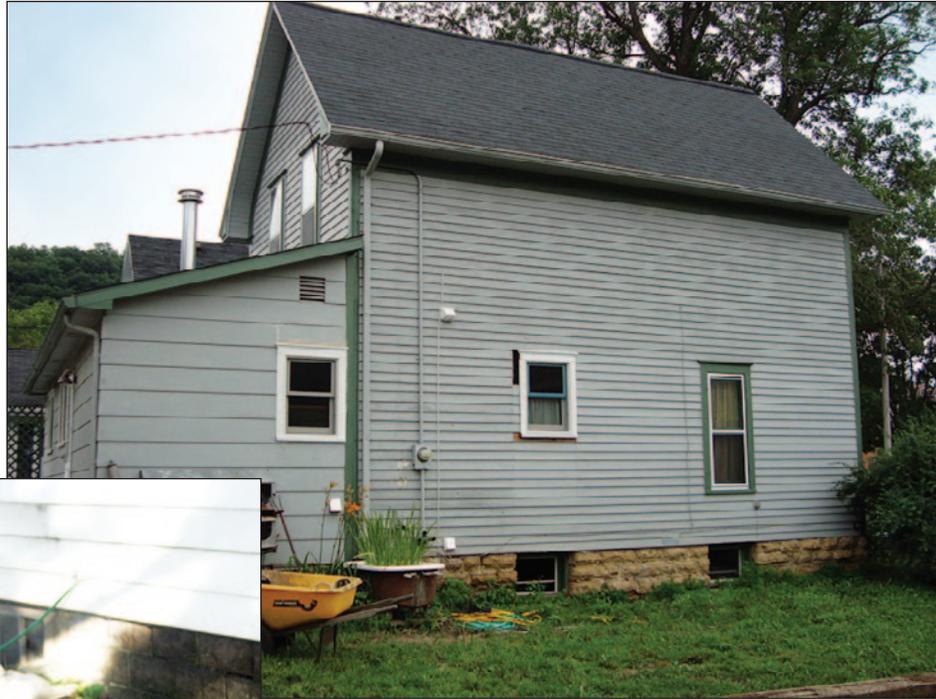
Figure 3-40.
This basement sustained damage to the mechanical and plumbing systems of the home (Waverly, Iowa).

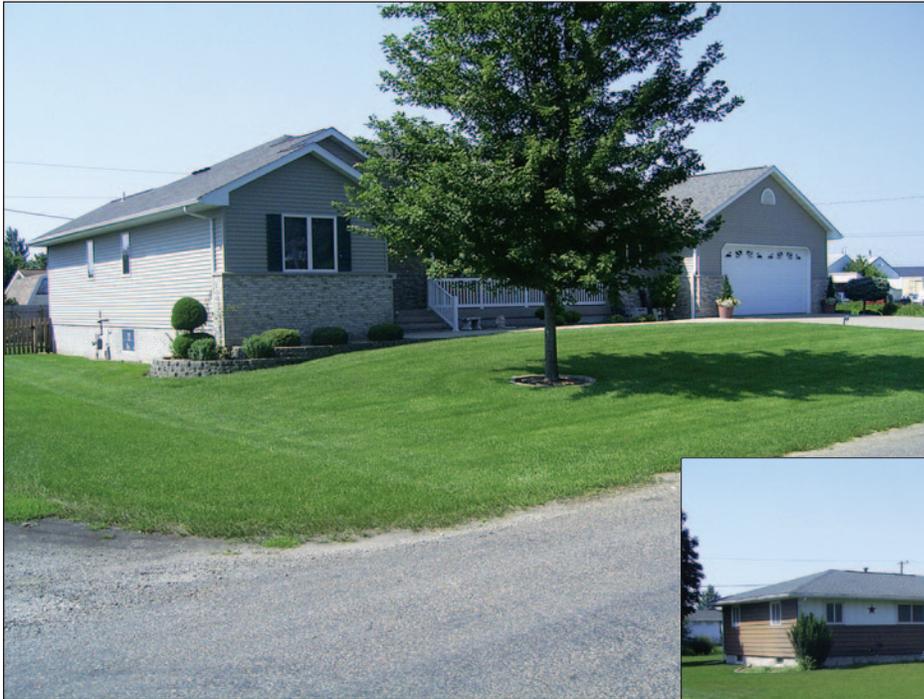
Figure 3-44.
This house located just outside the SFHA suffered no damage on the first floor (unlike the adjacent property), but the basement suffered damages to architectural finishes, electrical systems, and contents (Palo, Iowa).

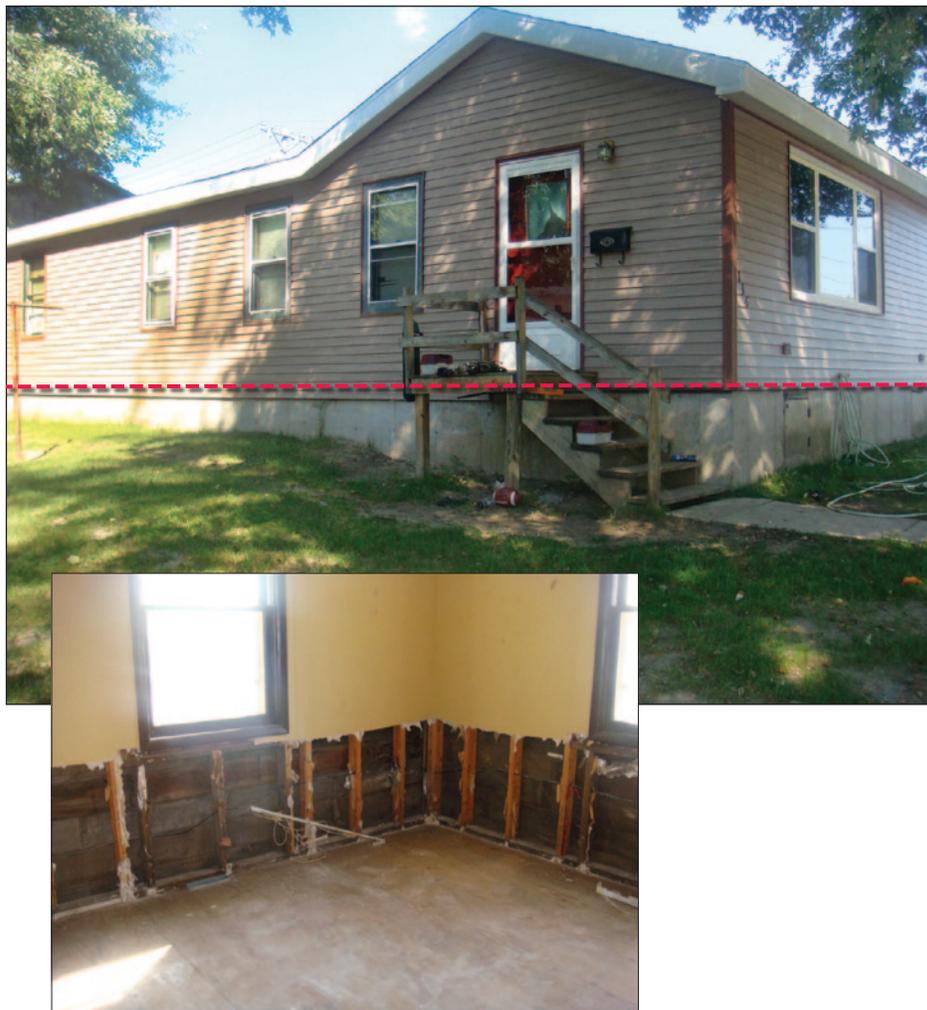
Figure 3-63. Structure in Reedsburg, Wisconsin, where the lowest floor is elevated 2 feet above BFE (red line shows the high water mark). The insert shows the interior of the adjacent pre-FIRM building had 3 feet of water above the first floor.

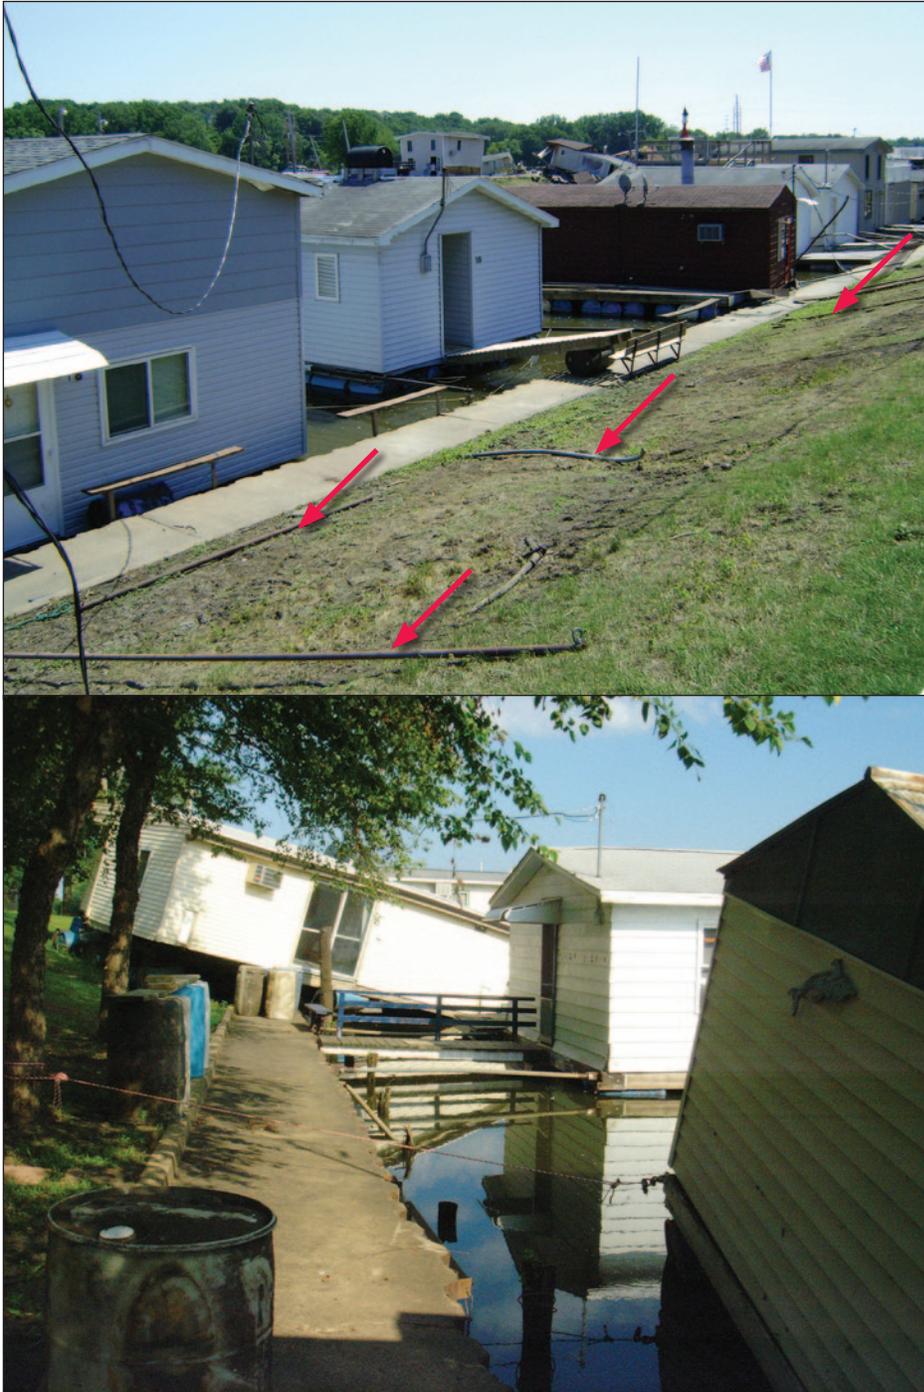
Figure 3-75.
Typical boathouse in the
Ellis Boat Harbor. Red
arrows point to damaged
anchorages (Cedar Rapids,
Iowa).

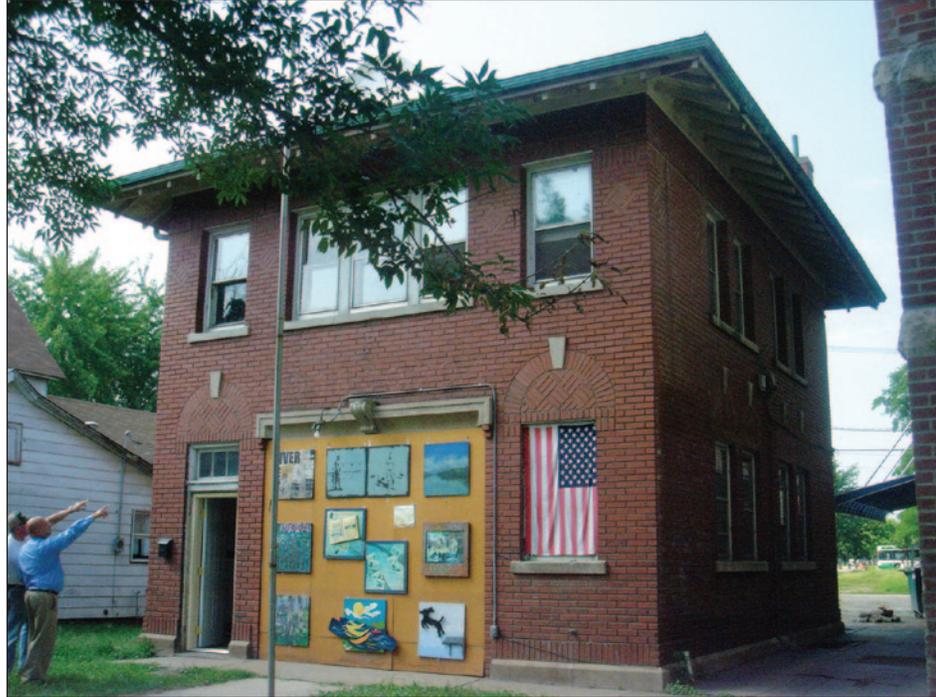
Figure 3-83.
The interior ground floor of this historic fire station was designed with glazed brick. This effectively wet floodproofed the building (Cedar Rapids, Iowa).

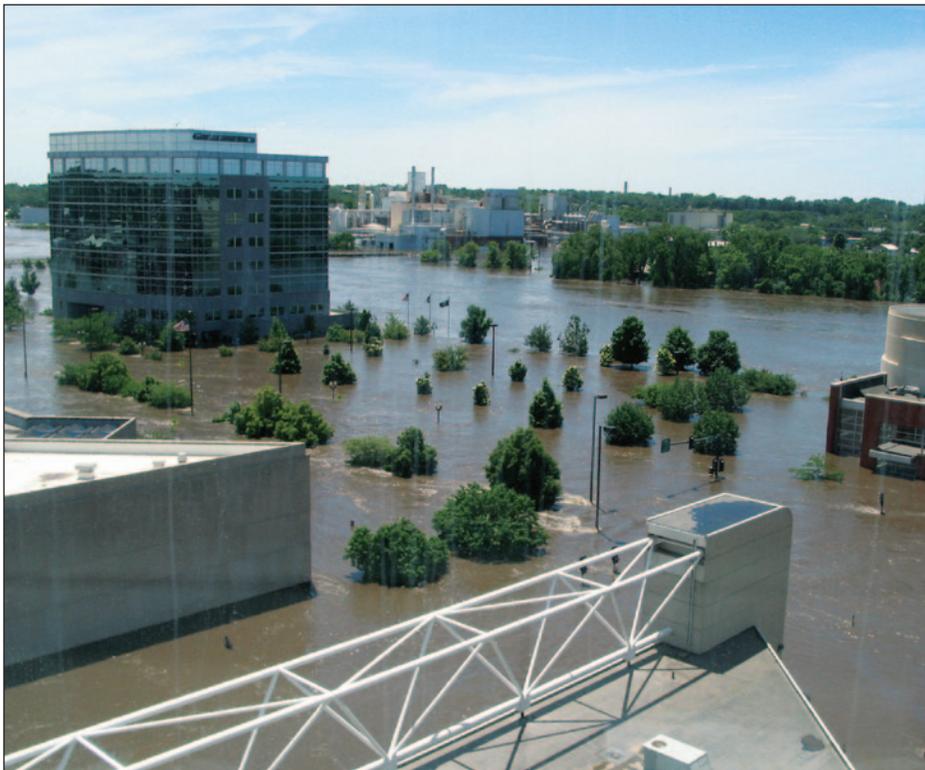
Figure 3-92.
The Great American Building sits along the Cedar River. Although it had a flood response plan in place, it experienced significant flooding on its ground floor. This property, in an A11 flood zone, has a BFE of 724 feet, and an elevation of approximately 720 feet (Cedar Rapids, Iowa).

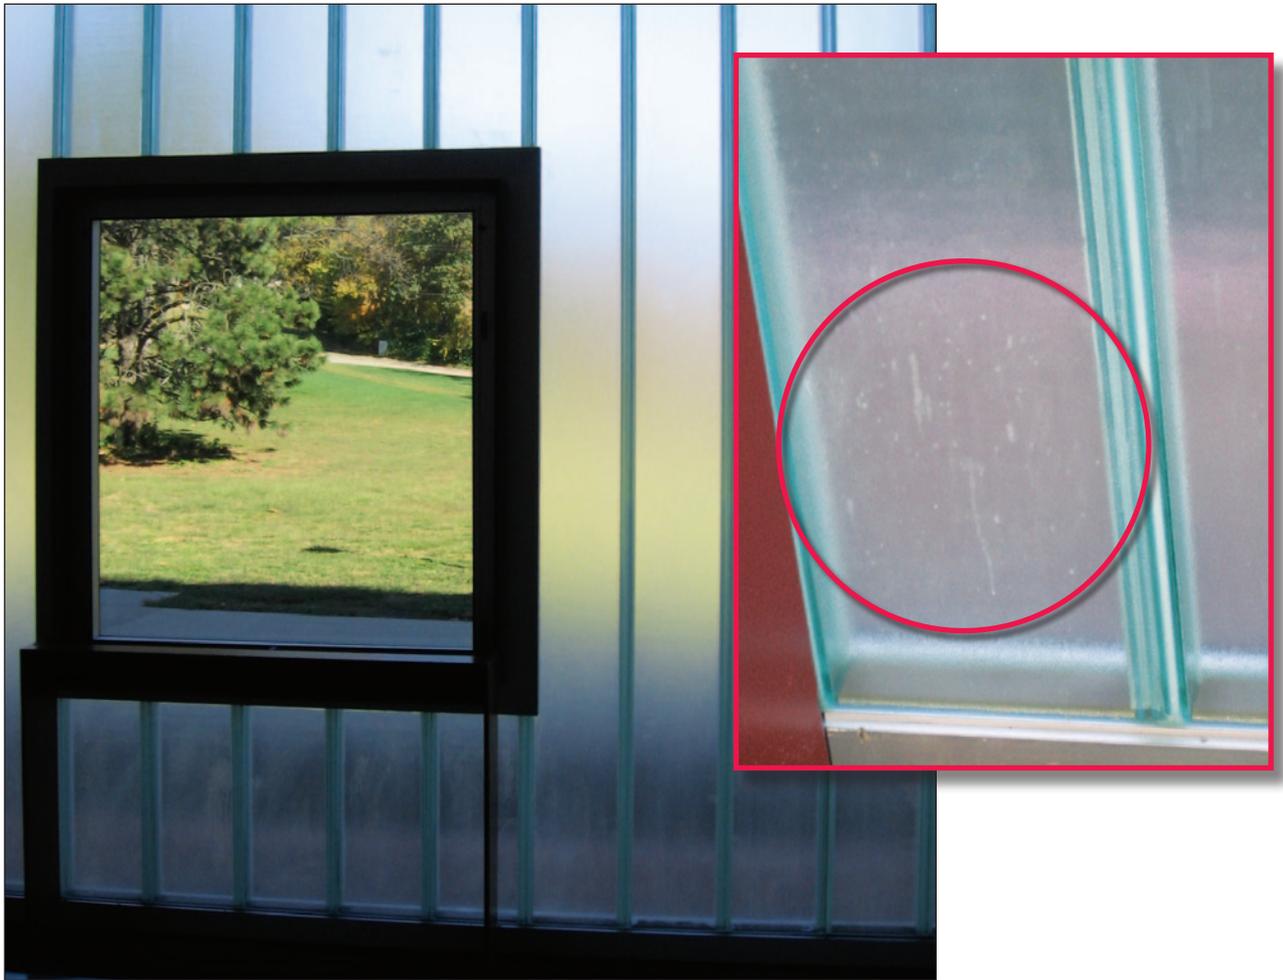
Figure 4-54. Double glass panels trapped river water between panes in structural glass walls at the Art Building West (Iowa City, Iowa).

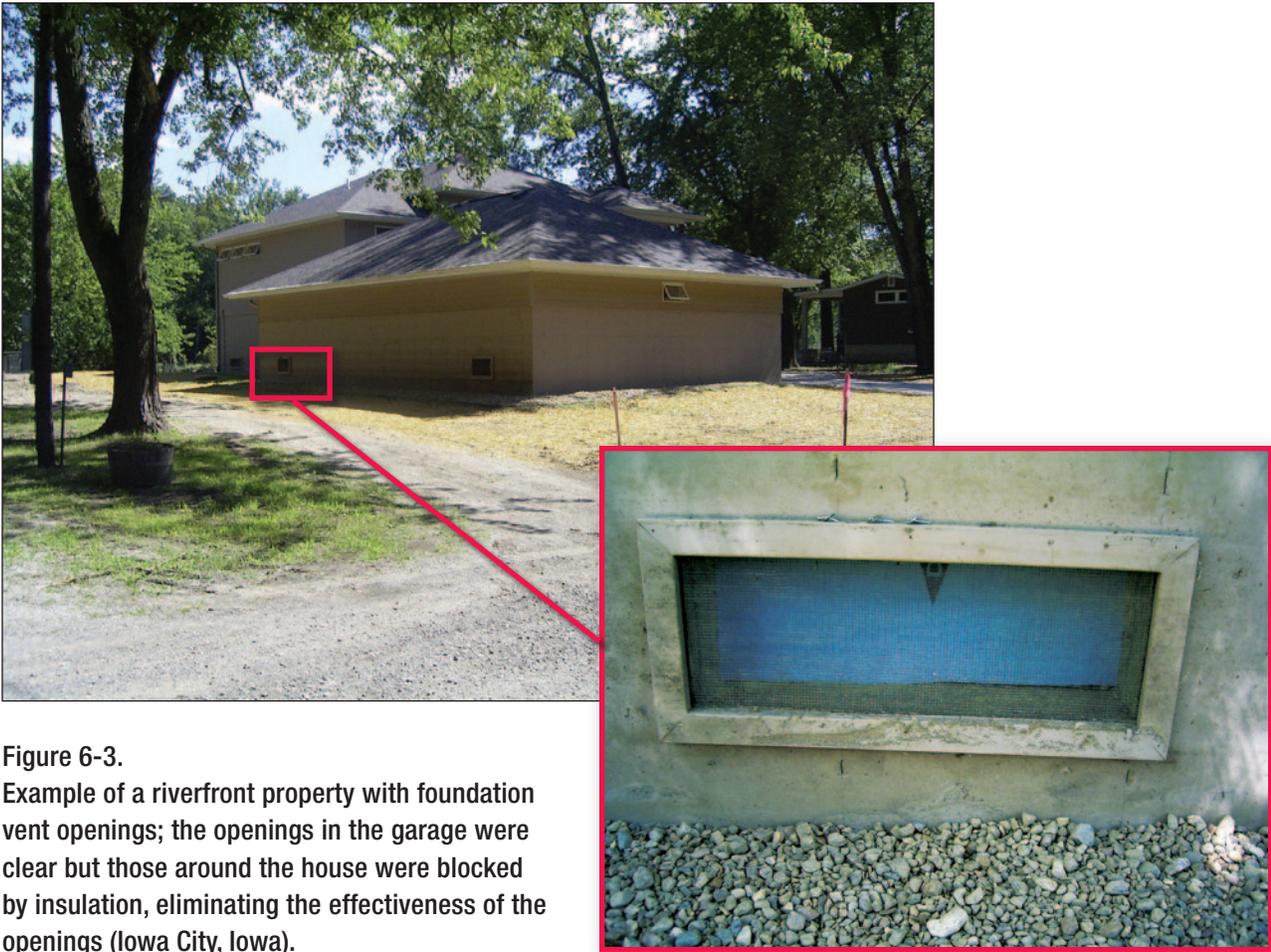
Figure 6-3. Example of a riverfront property with foundation vent openings; the openings in the garage were clear but those around the house were blocked by insulation, eliminating the effectiveness of the openings (Iowa City, Iowa).

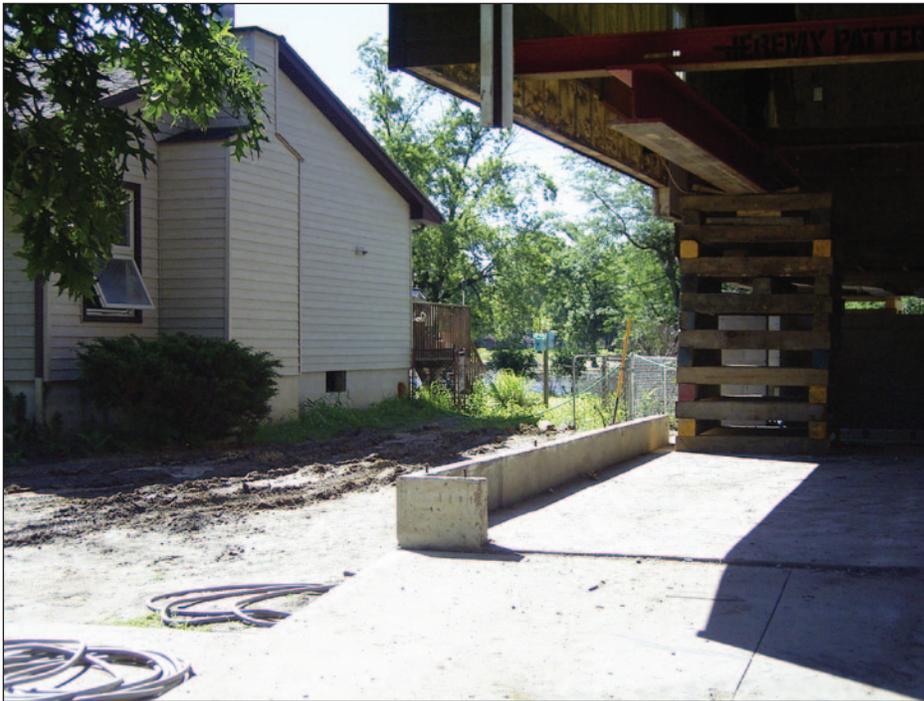
Figure 7-5. The property on the left was elevated to the BFE after flooding in 1993 (no freeboard) and flooded in 2008; after the 2008 floods, the homeowner of the ongoing elevation project on the right decided to raise his home 1 foot above the high water mark for the 2008 floods, which is almost 4 feet above the BFE (Iowa City, Iowa).
